STAINED GLASS: PARALLELS IN PRESERVATION

J I M L I N D N E R

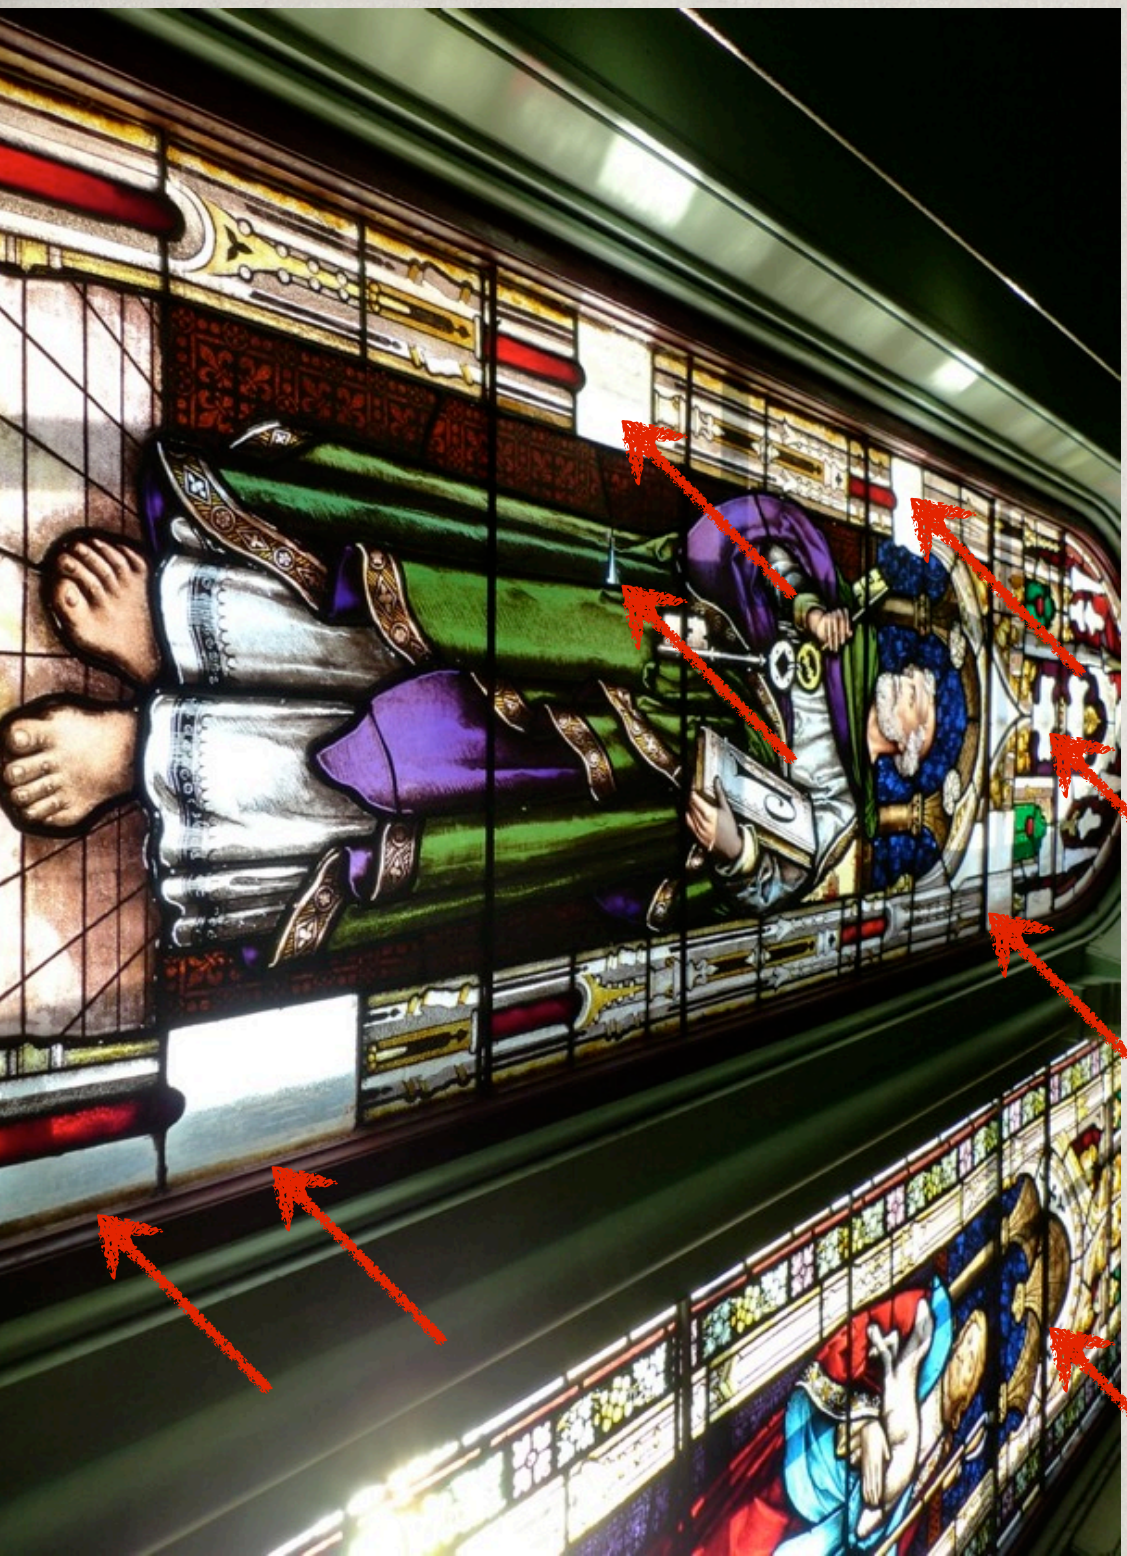
THE WINDOWS WERE ALSO DAMAGED

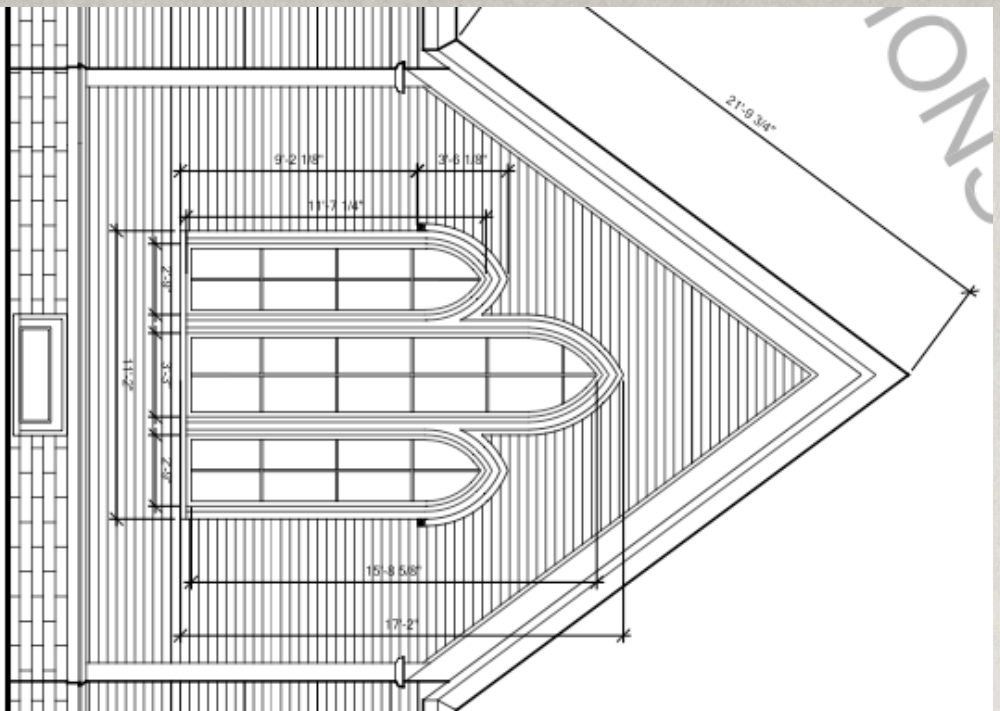
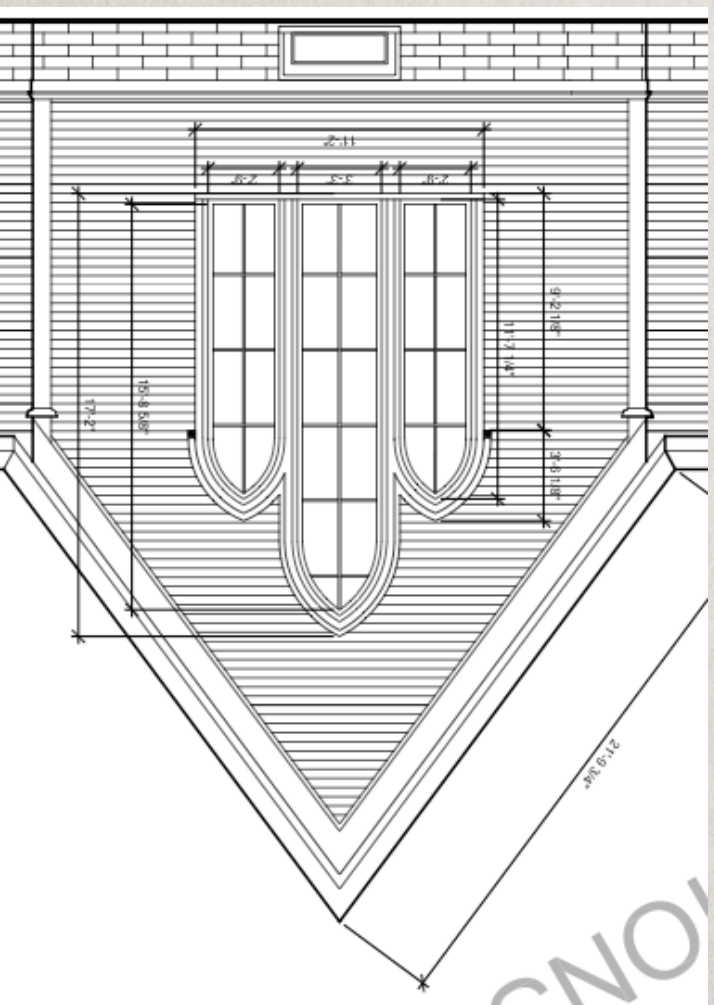
11'2" X 17'2"

ASPECT RATIO OF GOTIC WINDOWS SIMILAR TO HD - BUT IN THE OTHER DIRECTION!

☼ Windows 17'2" x 11'2"

☼ 1.54

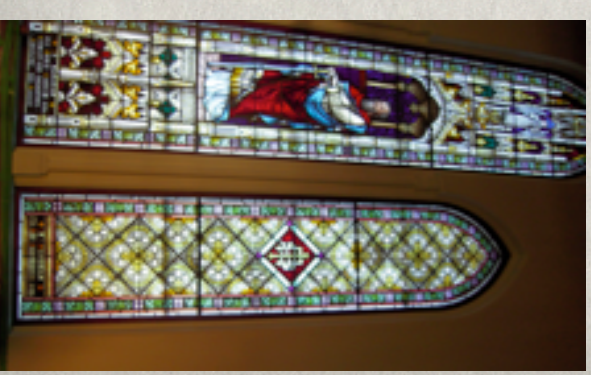
DAMAGED FLASHED GLASS

- ☼ Damage can explain how it was made

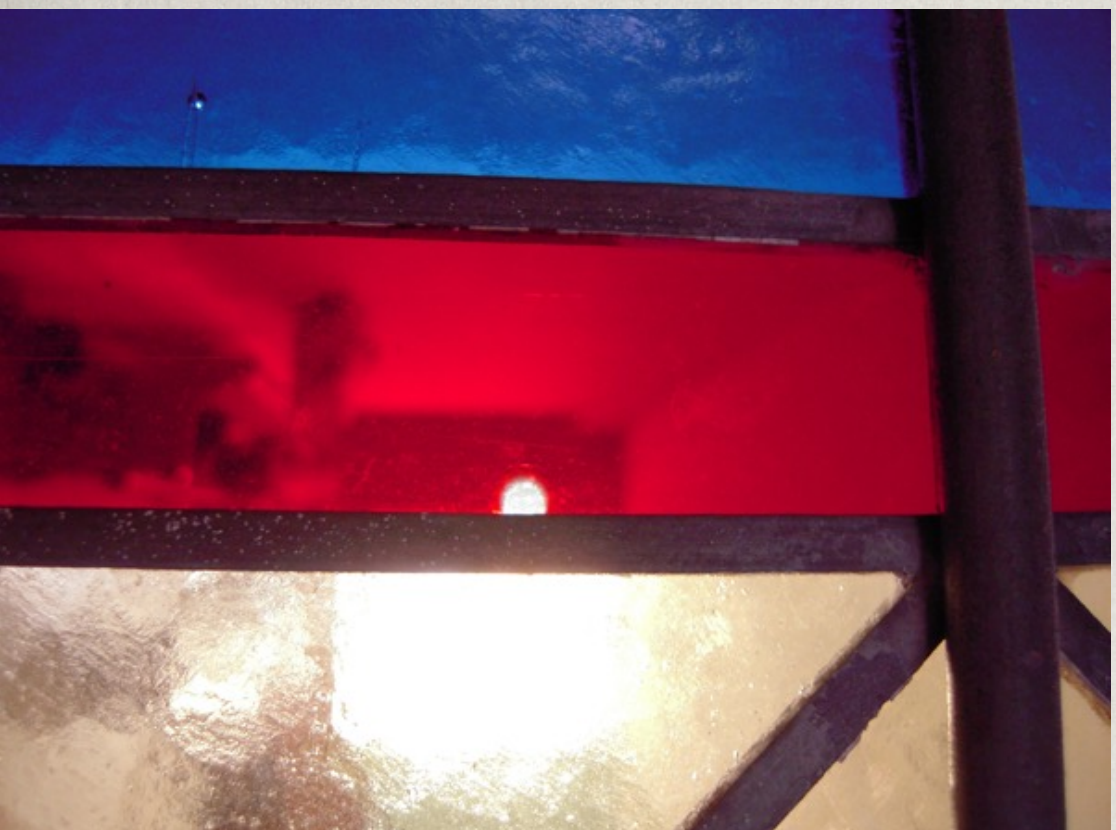
PAINTED GLASS WAS NOT
“BAKED” ON PROPERLY

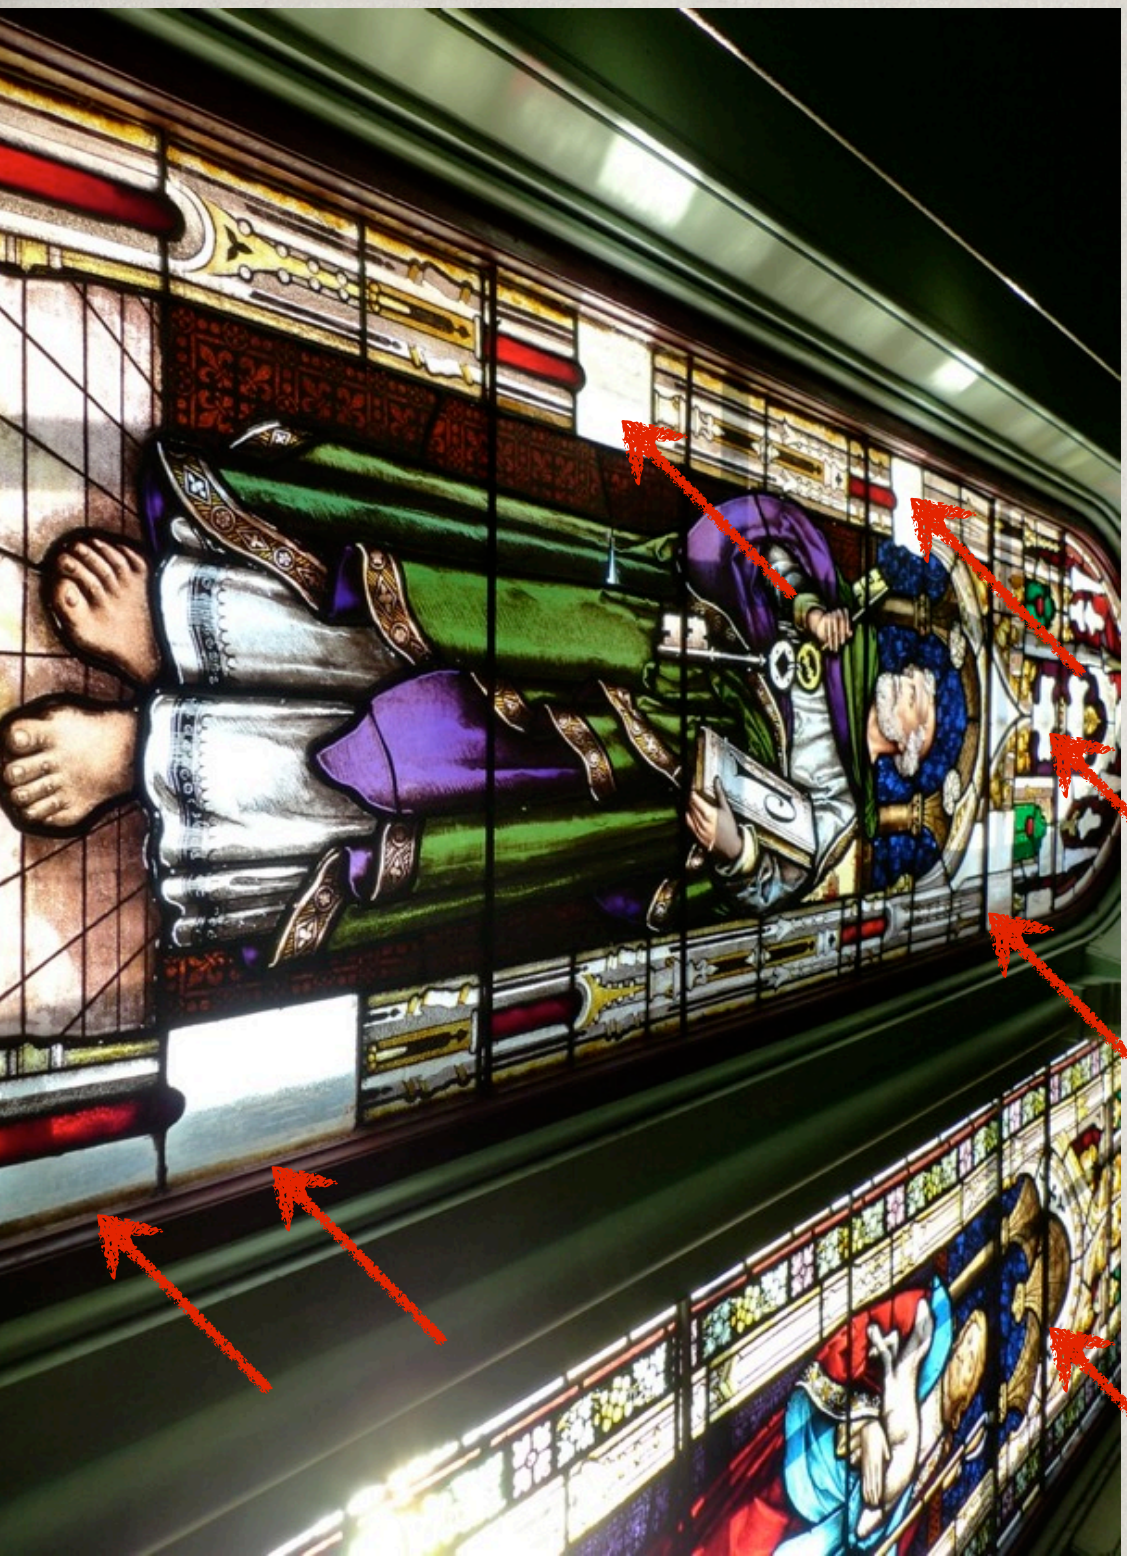
CRACKS POSE INTERESTING PROBLEMS

- ☼ Leave it the way it is - potential of catastrophic loss?
- ☼ Remove it and replace with blank glass - destroys the context of the entire Nave?
- ☼ Cement?
- ☼ Repaint?

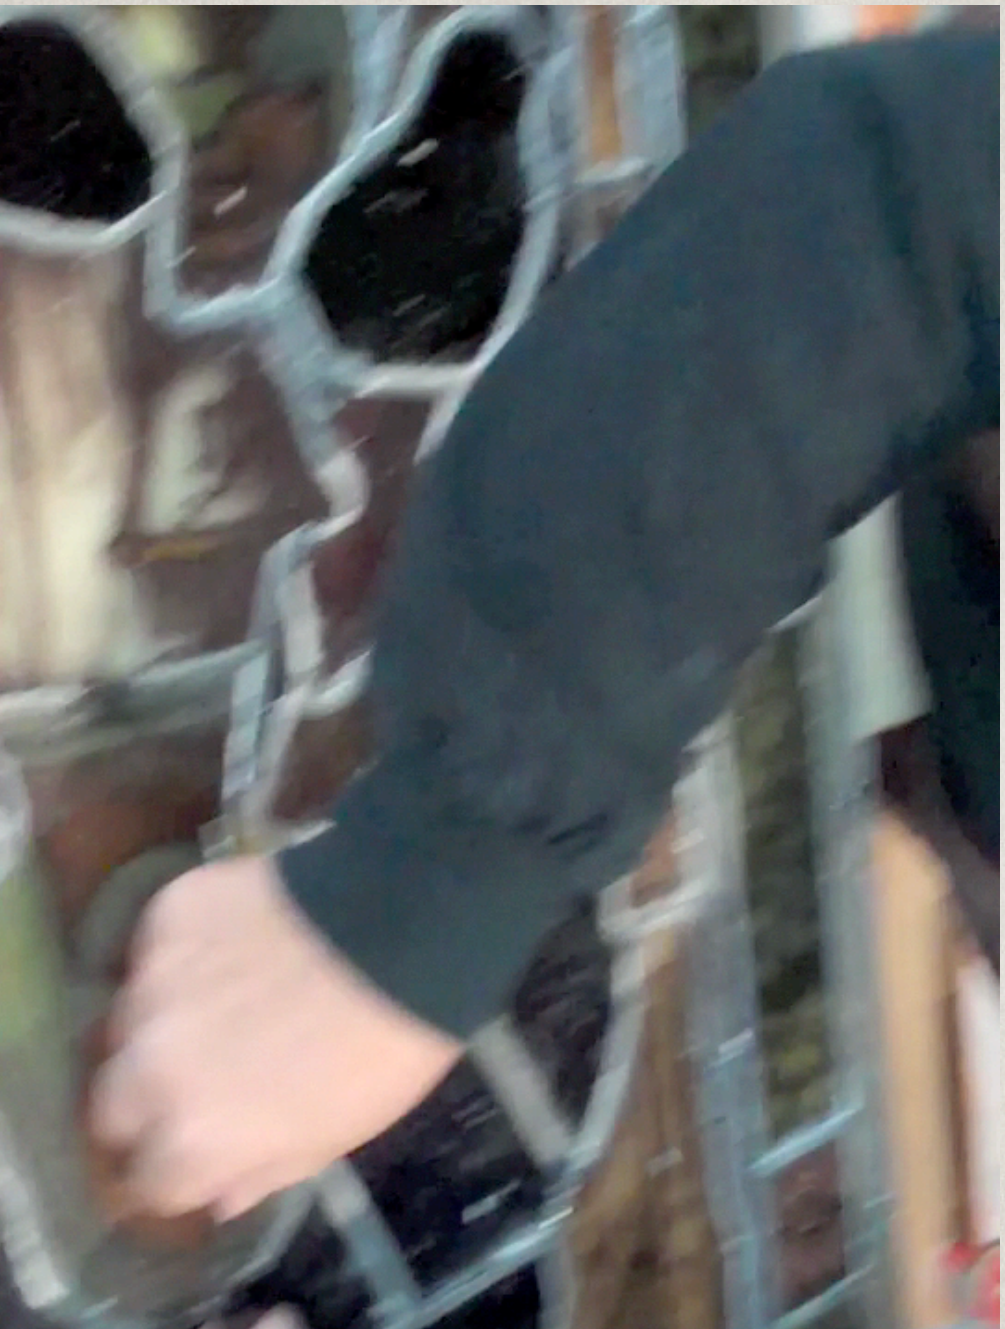
WHAT WE DID!

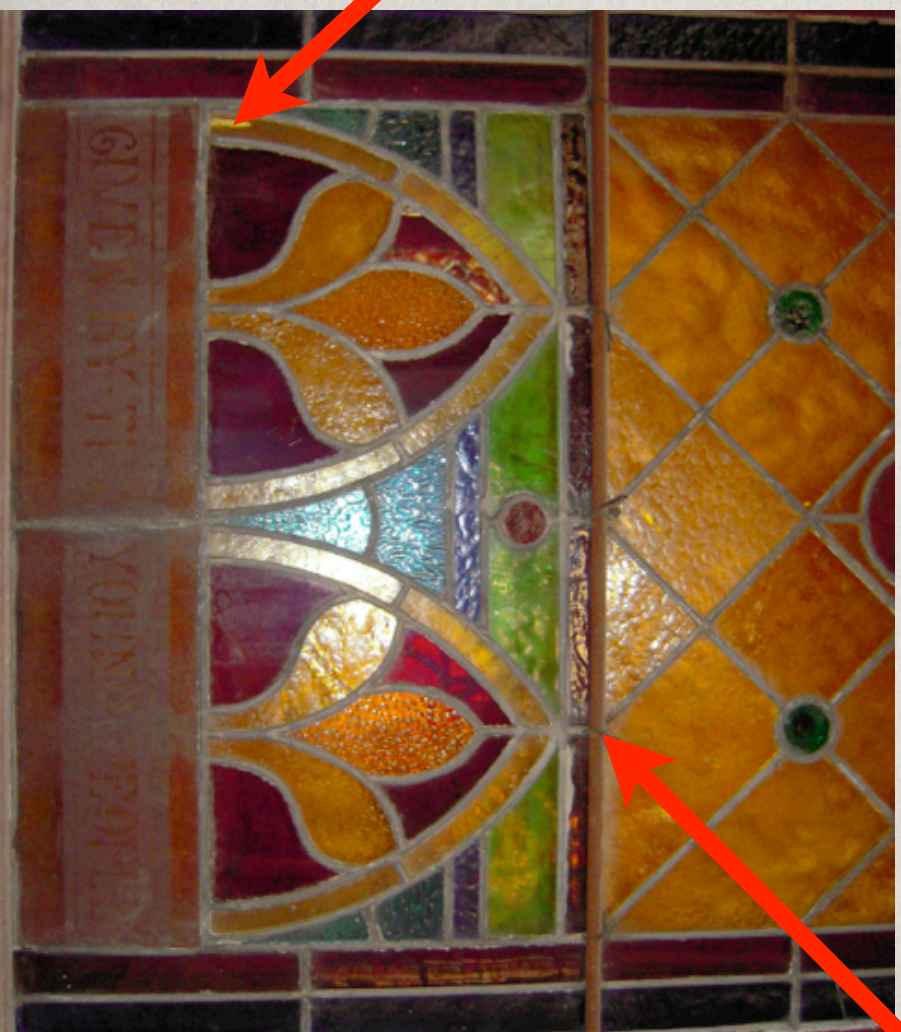
Condition Report

Window Location: S1 - Lower

Exterior Dimensions: H 33 3/8" slanting to 34" W 27 1/2" D 1 3/4"

Interior Dimensions: H 29 1/2" W 23 5/8" D N/A

Description of Overall Deterioration: excellent condition

Description of Damage	Location	Recommended Treatment	Action Taken
Oxidized lead surfaces	Entire window	Buff with Dremel tool, re-cement	completed
Drilled holes in frame	Upper section of frame. 7 1/4" from top	None	none
Bowing - minor	Top section	Don't remove. Apply gentle heat and pressure to realign. Then consider adding rebar to prevent future bowing.	new rebar soldered to lead came
Fading Paint due to improper cleaning	Painted memorial panels	No repair possible short of making new panels	none
Frame is separating	Bottom left, more so than right (as viewed from front of window)	Wood glue to secure sections and discourage further spreading	completed
BACK			
Dusty	All over	Re-cementing process will clean glass.	completed
Cracked & Missing Cement	Along most lead lines	To be refreshed with new cement	completed
